## CASE STUDY:

### Crane mounting.

## OVERVIEW

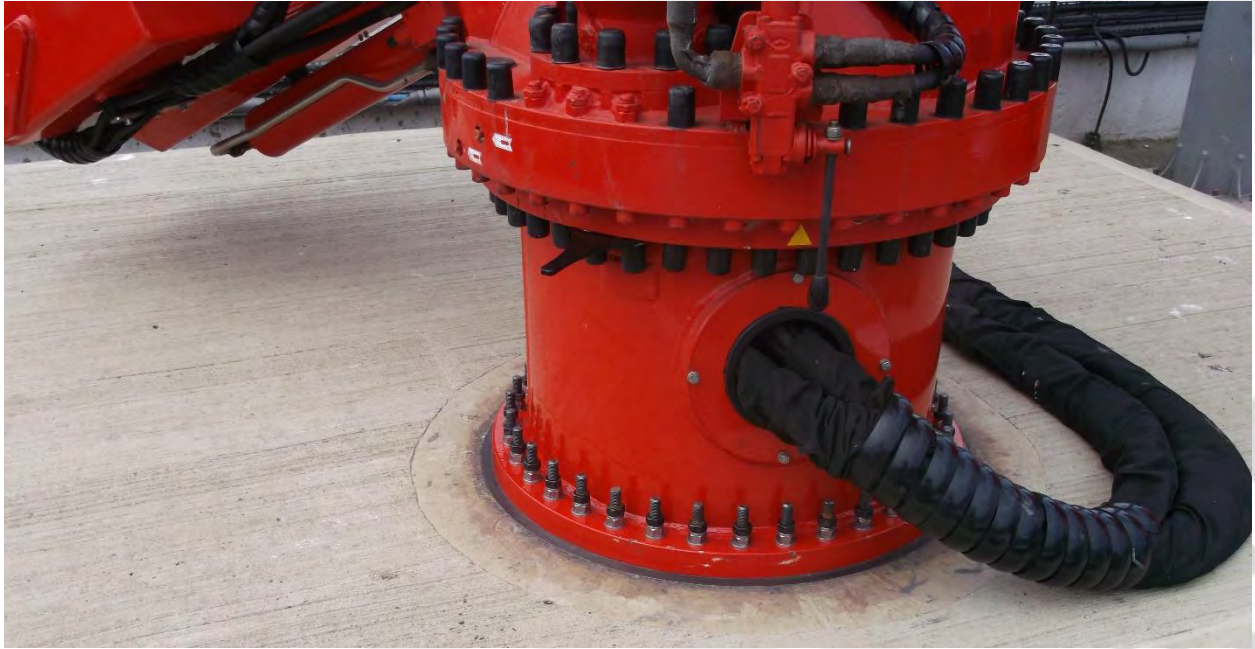
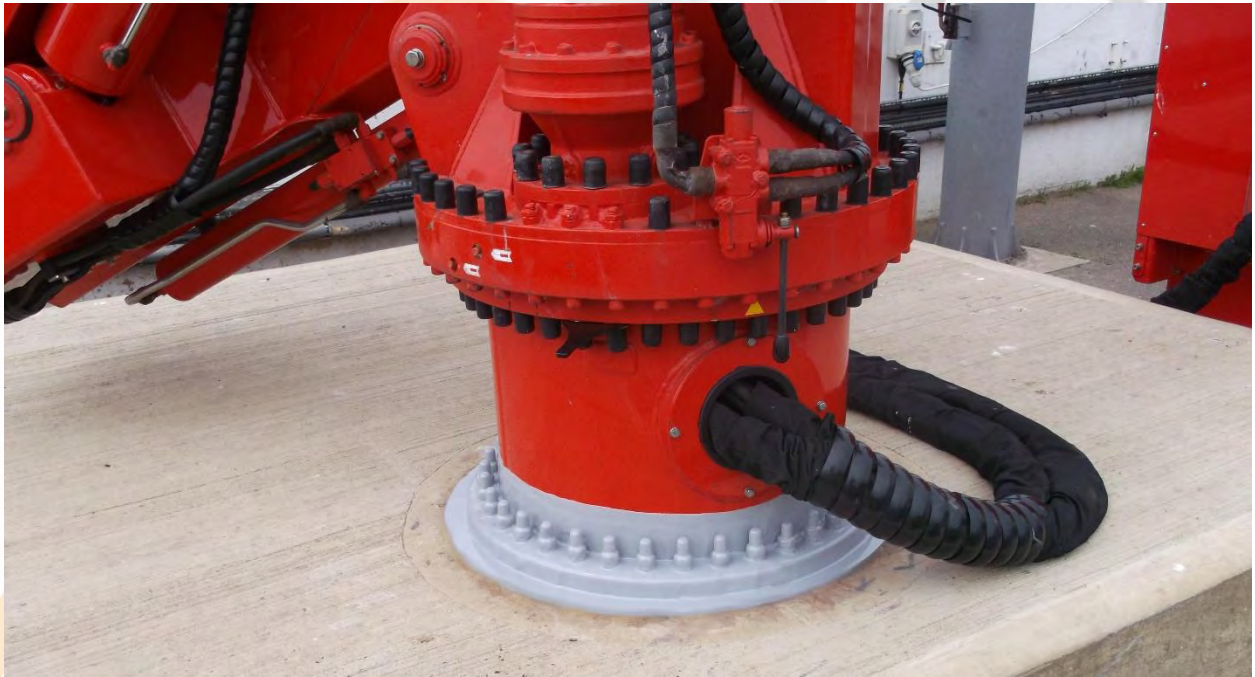
Prep involved simple solvent clean down and removal of plastic thread caps. Technician coated approximately 3 inches up the main structure and 1.5 inch onto base plate.

3 coats of Z-FP light grey.
