CASE STUDY:

Gas feed Lines

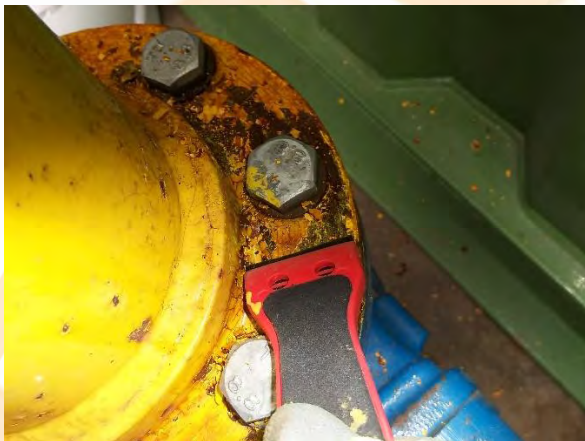
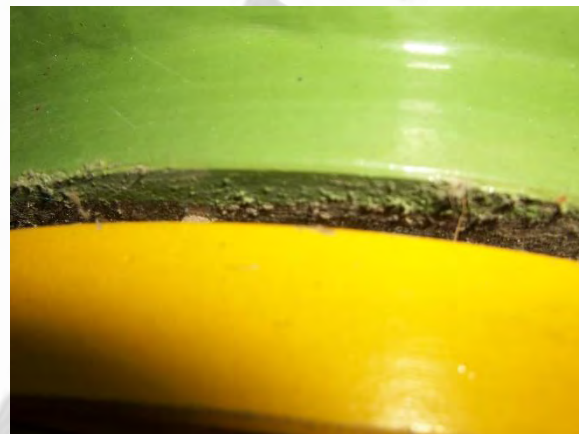
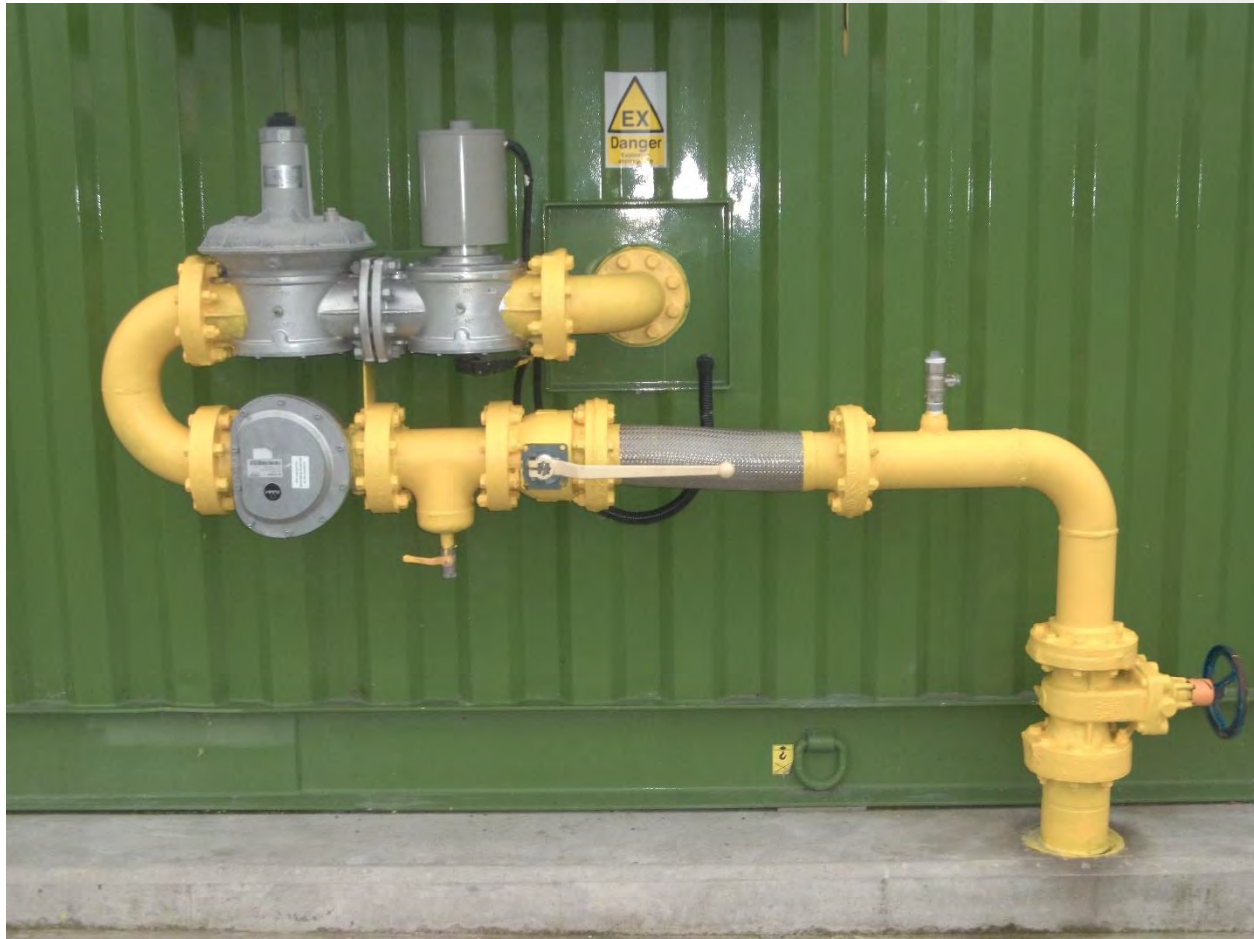
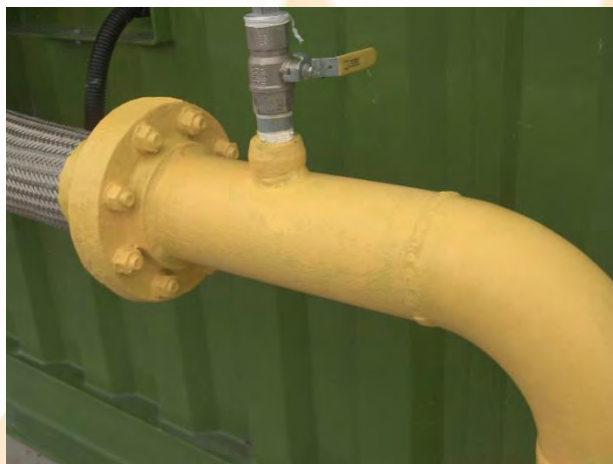
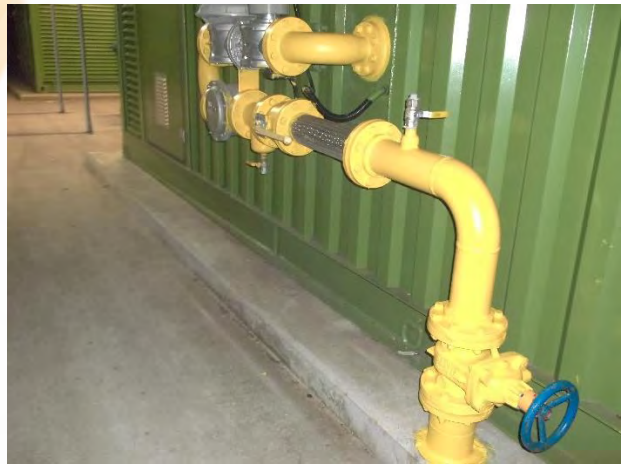
Images

In November 2020, Zerosion Corrosion Defence were contracted to provide dedicated care 10 x live gas feed lines. The lines had been neglected for several years and corrosion and oxidation had caught hold on the lines. Zerosion were called in to provide asset life extension to the lines and to arrest instigated corrosion and protect them for the future.

The remit on the project was simply to arrest the established corrosion and protect the lines for the future. We opted against coating the stainless expansion joint, filter, and condensers – as they are stainless and galv.

We started by sniff testing all lines to check for escaping gas, then moved on to cleaning each line using a plastic scarpers and plastic blade, to remove flaking paint loose rust, ensuring that we expose any areas where oxidation had found any type of vein. Once the entire line was free from debris and no corrosion was left hidden, we cleaned 5 of the lines within the area with a solvent degreaser, as there was glue and grime on the surface. Once cleaned, we went over with the ACI to kill any oxidation on the surface and remove any ingrained corrosion, properly and carefully. Once we were happy, we applied the adhesive to the flat lines and the white ACI primer to the flanges, ensuring the faces of each void and each thread was coated. We then applied 3 coats of Yellow Zerosion to ensure long term protection.
