CASE STUDY:

Compressed Air Lines

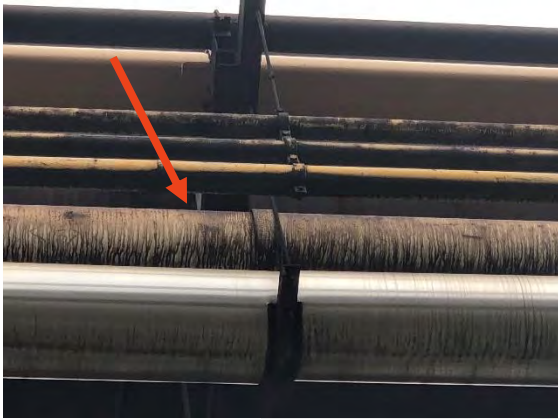
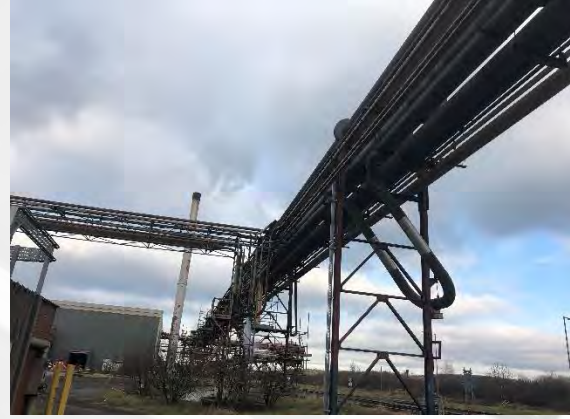
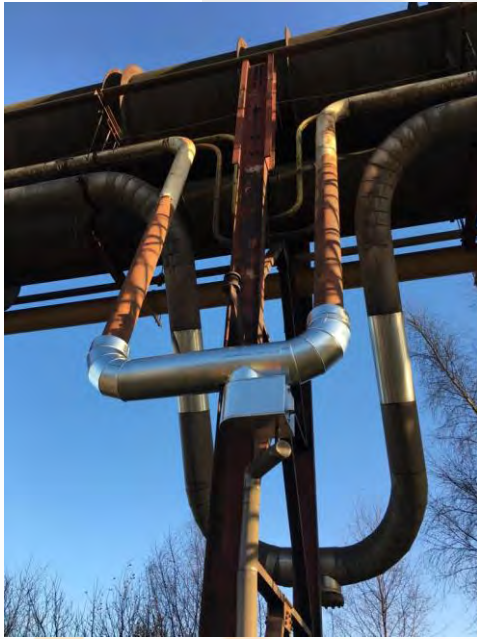
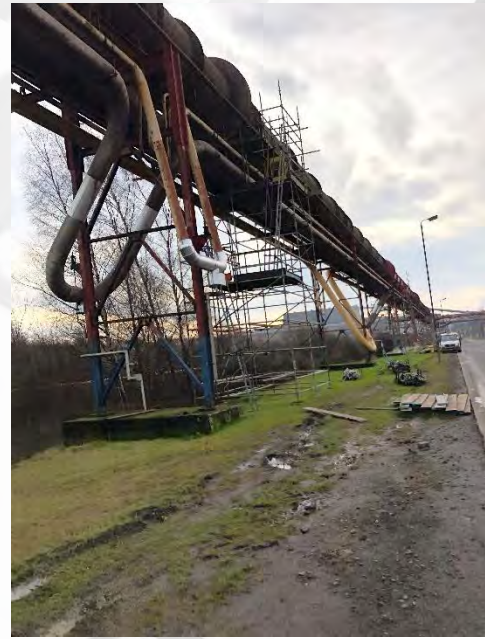
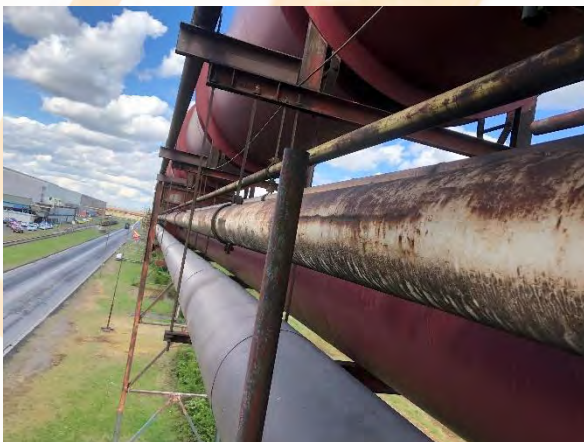
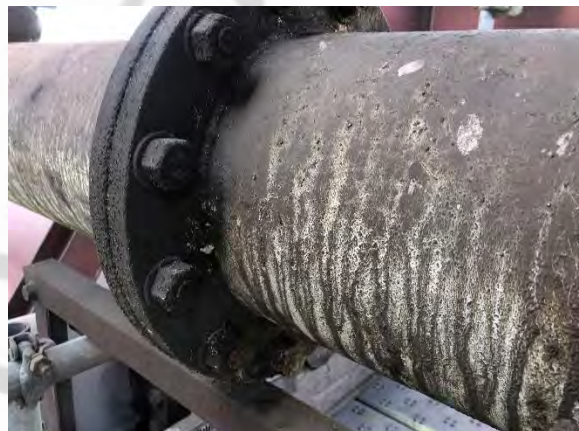
Before

We were tasked to provide pipeline protection to around 600 meters of live 12” compressed air line. The airline, situated 5m from trestles, showed clear signs of corrosion and scarring from environmental decay and consisted of straight runs, moisture traps, diameter changes, flanges, valves and suspension brackets, the line was mainly situated on uneven ground, causing access issues and also traversed road and rail line..

The project started with a thorough clean of the line, to remove the dirt, chemical and grime from the line, this was undertaken using a solvent based cleaner & scouring pads.

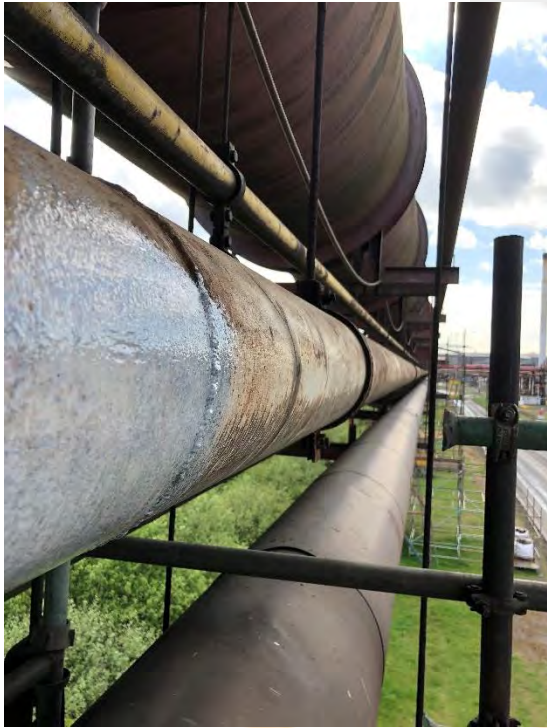
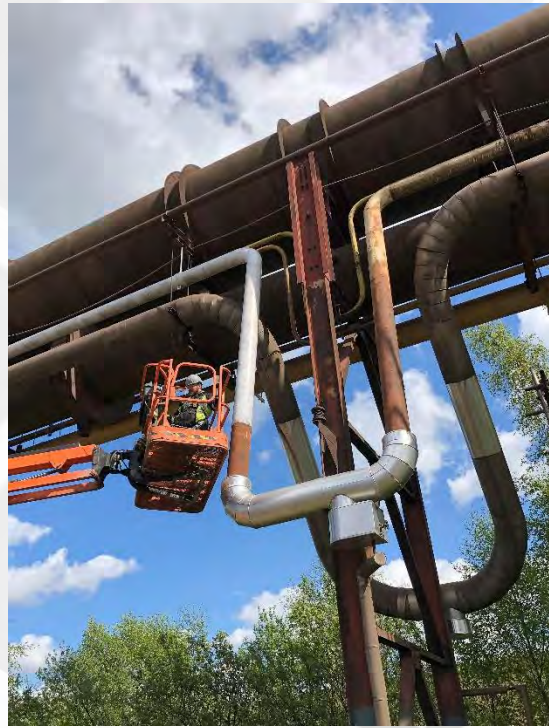
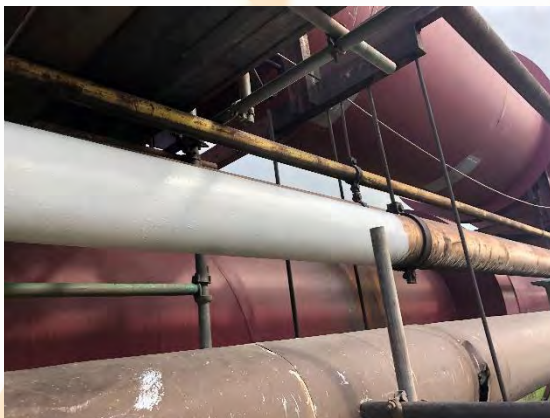
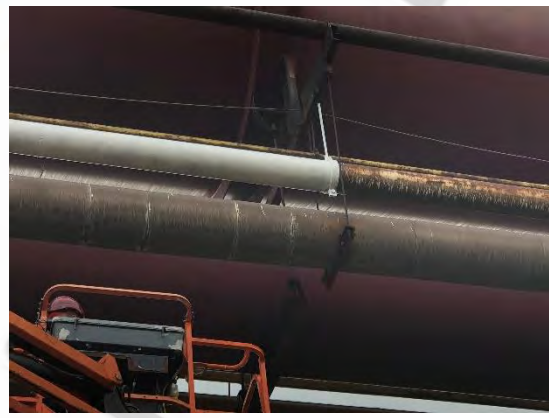
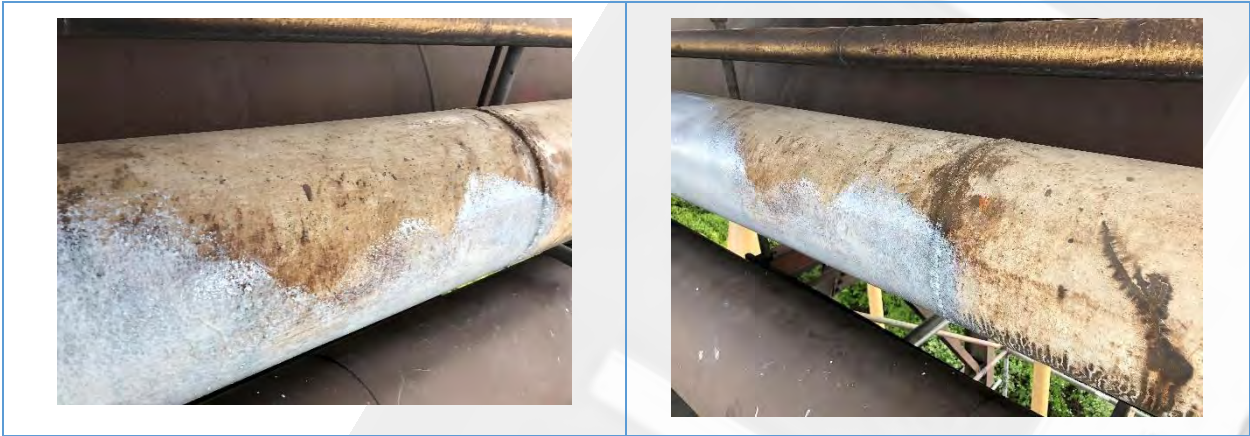
During

Once the line was cleaned thoroughly, an application of the VCI corrosion inhibitor was applied in sections along the line, to enable the team to apply a coat of Z-SP to the prepared surface, a specific area at a time. Due to the issues relating to access, the decision was taken to apply VCI, then 2 x white coats in “one sitting” at one entire length of boom access of the MEWP.

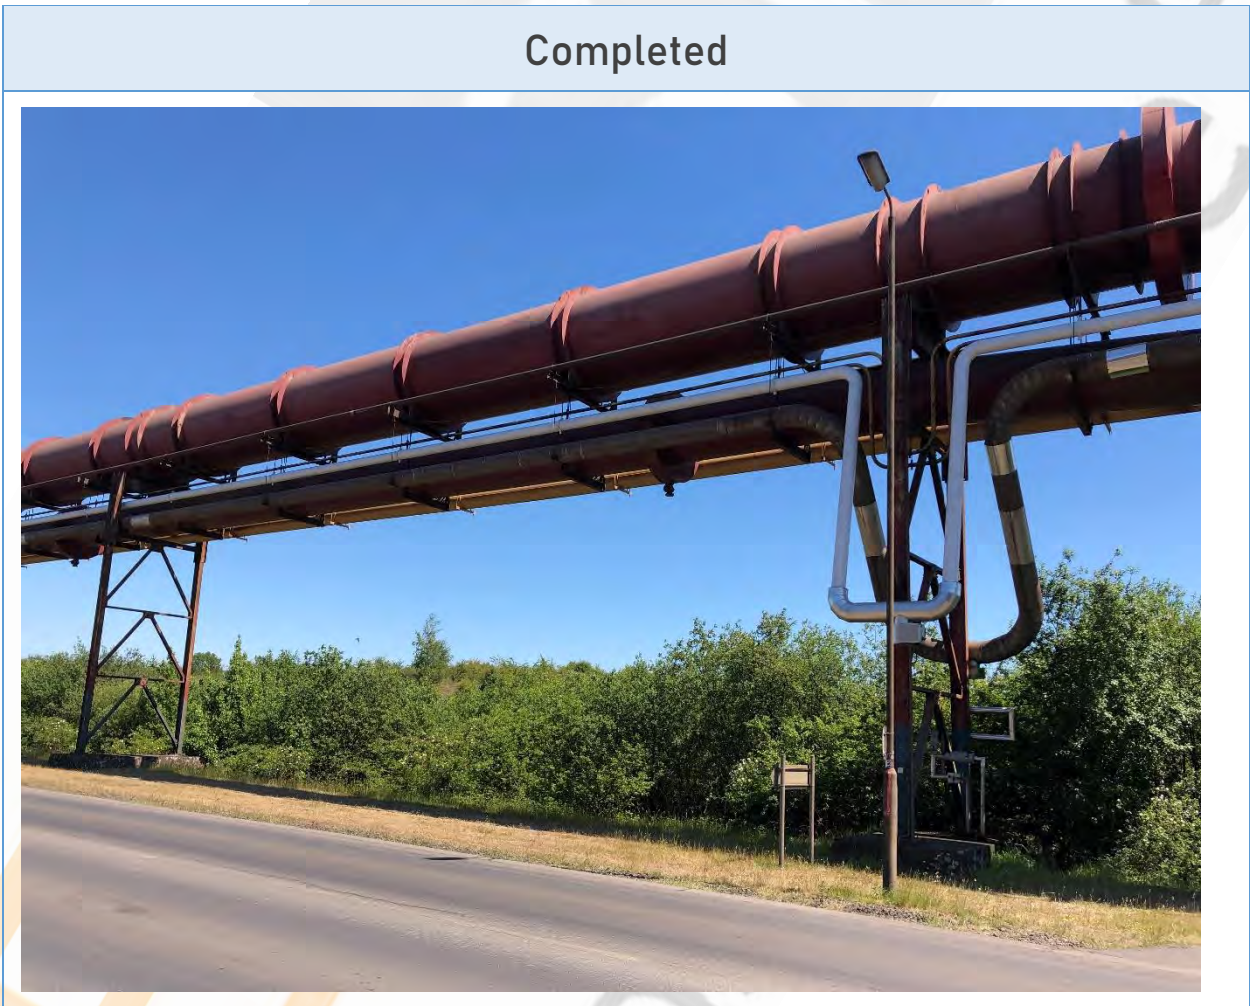
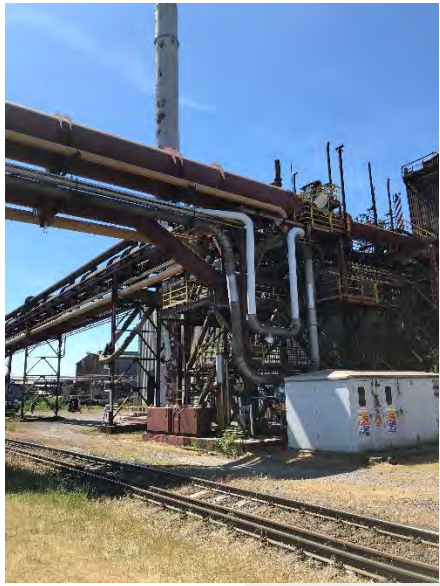
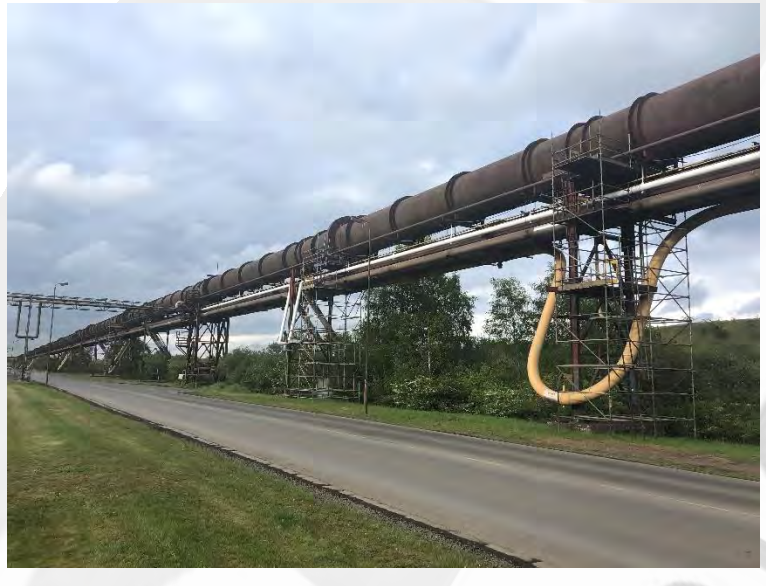
Completed

Once the entire line was coated in 2 coats of Z-SP, the team went over the line with a third, topcoat, to ensure comprehensive protection.
