CASE STUDY:

Gas transfer lines

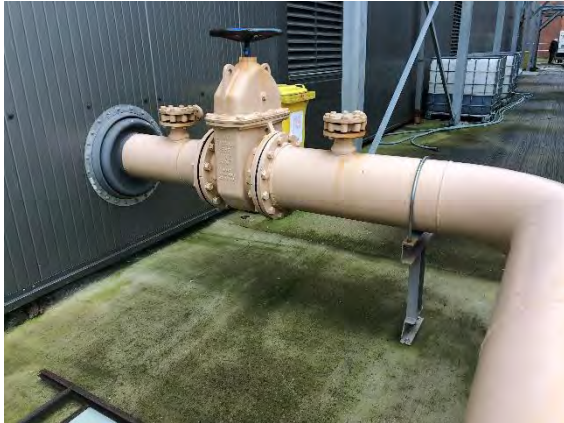
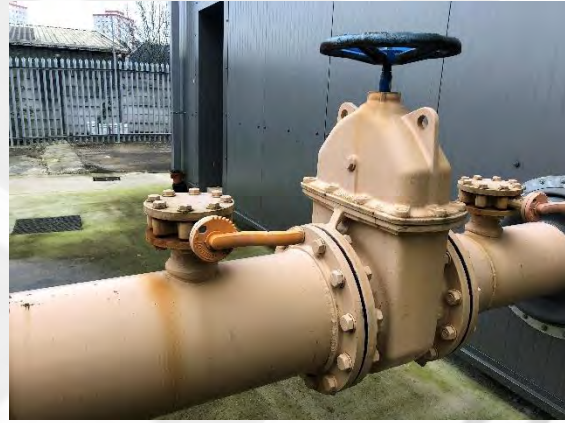
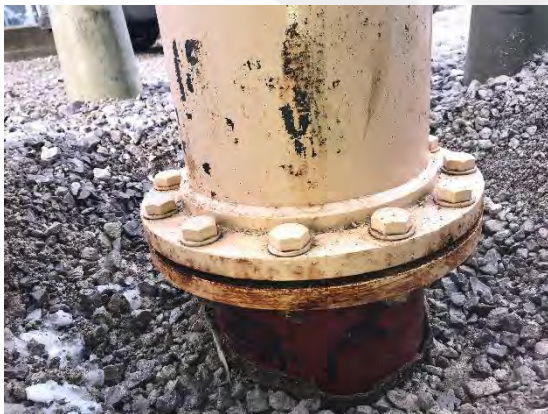
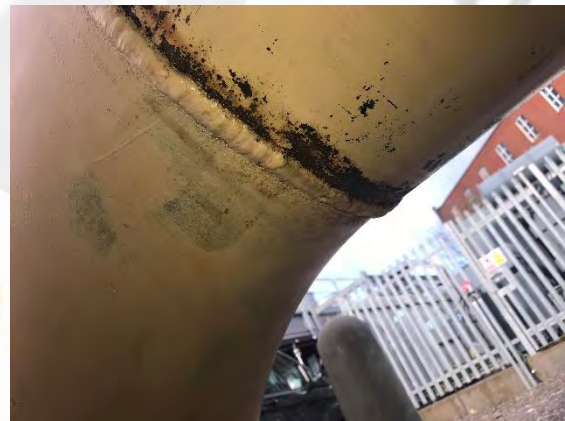
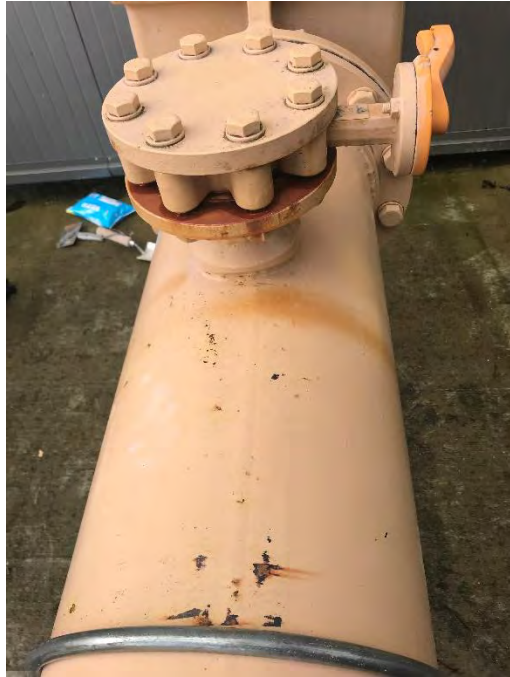
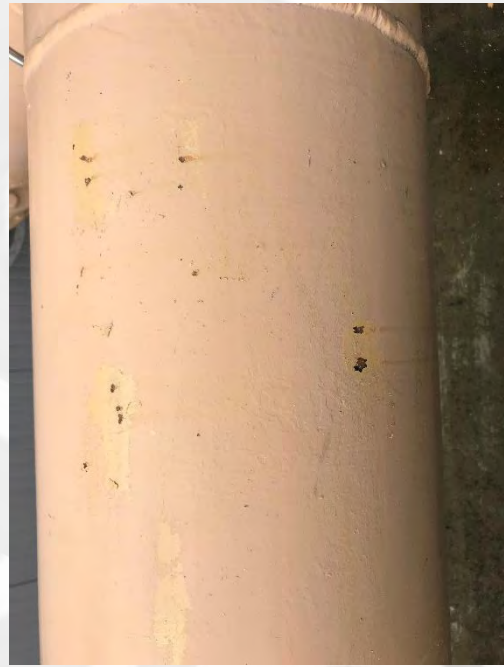
Before Zerosion coating

We are lucky enough to work with some fantastically forward-thinking companies, who are strong believers in preventative maintenance and catching and arresting issues, before they become problems. In 2020 we were asked to carry out quick response works on a boiler feed live gas transfer line, for a utilities company on a power station in Oldham. During a 6 monthly inspection, onset corrosion was found to be present on the line body, bolted flanges and valve bodies of the line and required quick response to rectify the problem, we conducted a site survey at the end of Jan 2020 and were on site 3 weeks later to fully clean, prepare and coat the 6 meter, 10" line and assorted flanges and valve, and to arrest the corrosion and further decay.

The project was to provide immediate action to prevent the corrosion on the line worsening. We were unlucky enough to be called to action during the freak weather of early 2020, whereby record rainfall had fallen in the North West. The project had to be completed in accordance with application guidelines, meaning the substrate and environment had to be dry AND in accordance with local orders treating this as an immediate action requirement. Once we had a break in the weather, 2 technicians attended site for two days to hand prepare the surface, to expose and treat any corrosion on the line, flanges and valve head, which included digging out a flange section that was covered in shingle. Once the surface was fully dried, prepared and corrosion inhibitor applied, both sections of line were coated in Zerosion. Due to the action of burying on of the flanges in shingle, we applied a 1.5mm coating to the flange and downpipe, to provide stronger anti-abrasion protection.
