## CASE STUDY:

### Pit valves

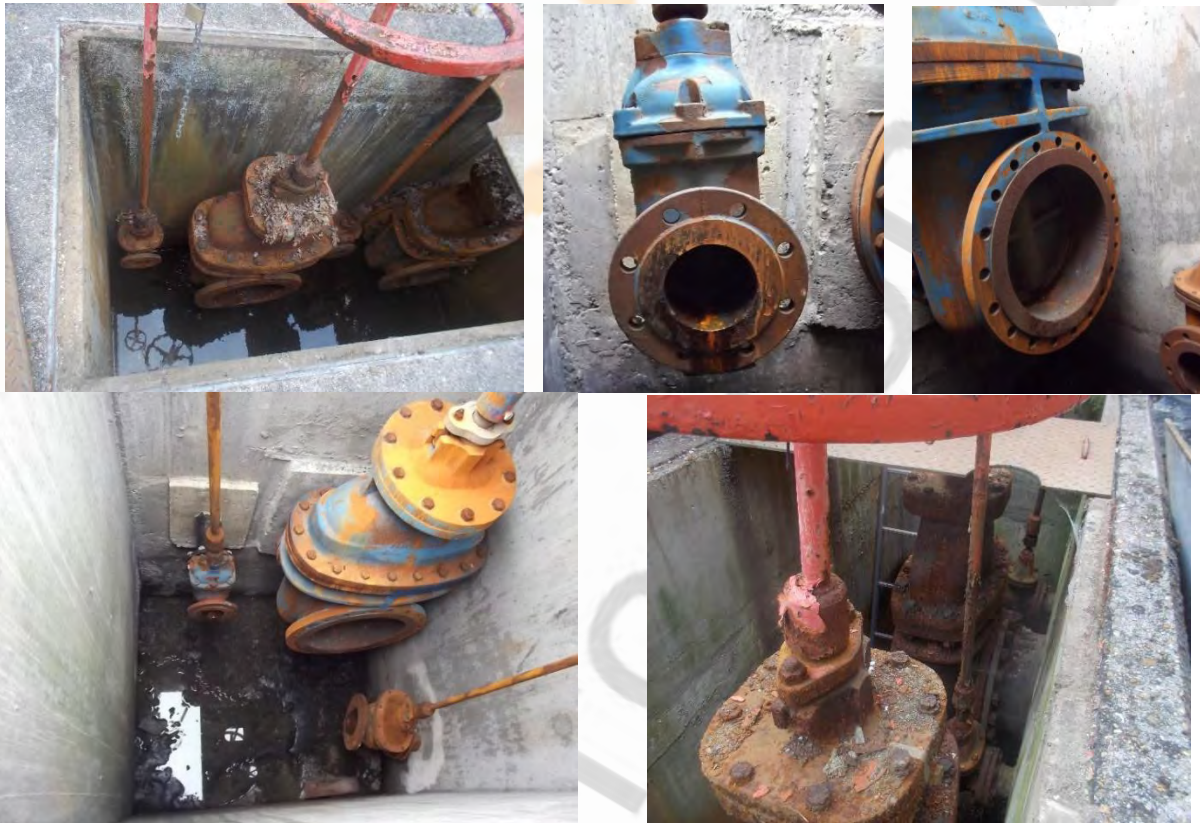
The valve assemblies had been in situ for 20 years and showed signs of their age. The client needed them protecting for the long term as a fit and forget system, that they can operate, should they need to.

The valves were all cleaned using standard solvent cleaner and a brass wire brush, as there are quite a bit of oil and grease residue on the bodies. Once clean, a coating of the Zerosion Z99 and Z100 oxidation remover was applied, to ensure all crevices were free of moisture / oxidation. We then applied a 30µm coating of adhesive primer all over the body of each valve, each valve was left to fully cure (in the heat it didn't take long), before 3 coats of Zerosion was applied to the surface of each valve, in turn.
