CASE STUDY:

Lokring protection

OVERVIEW

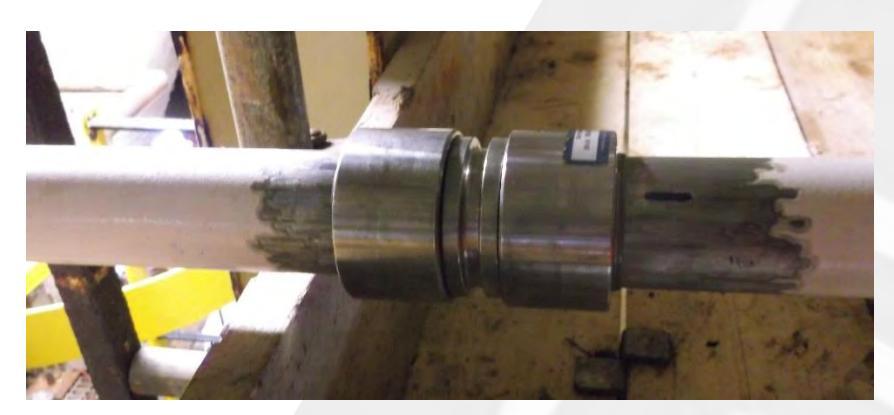
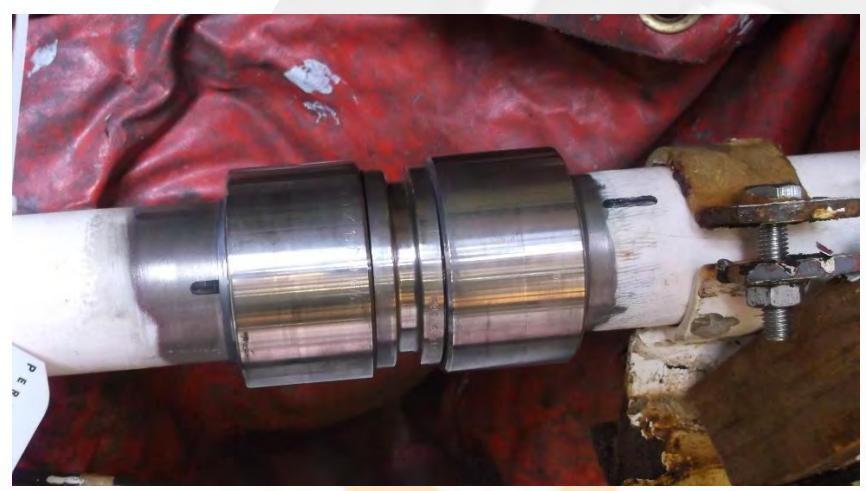
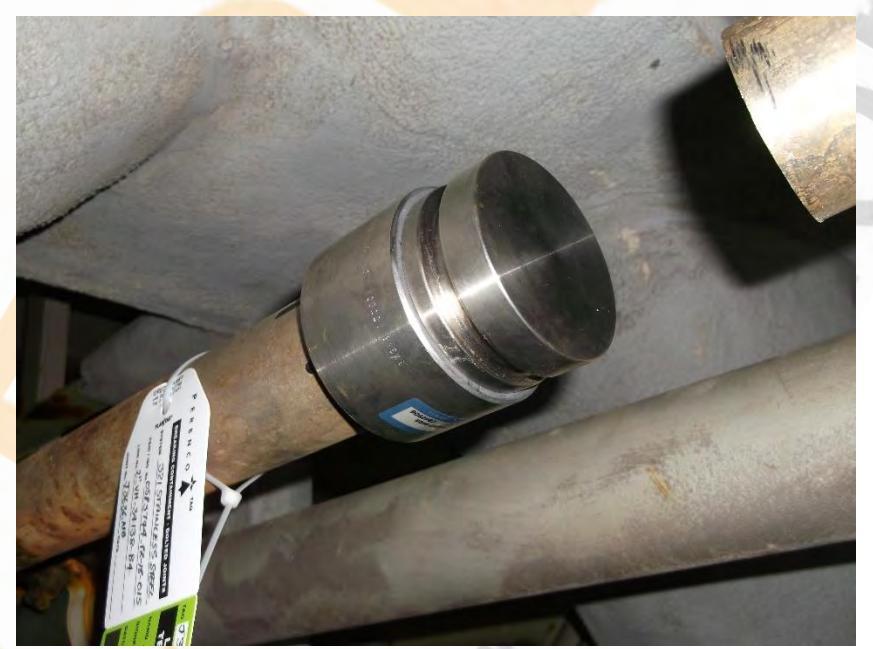
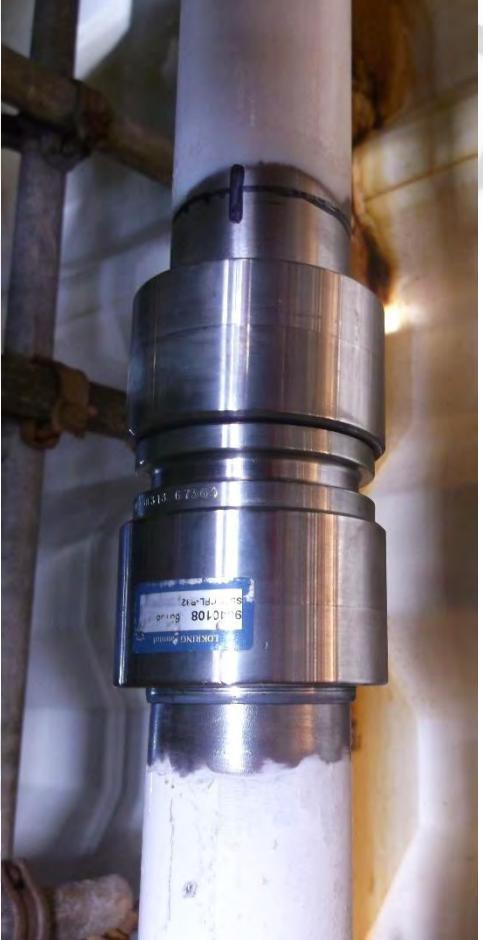
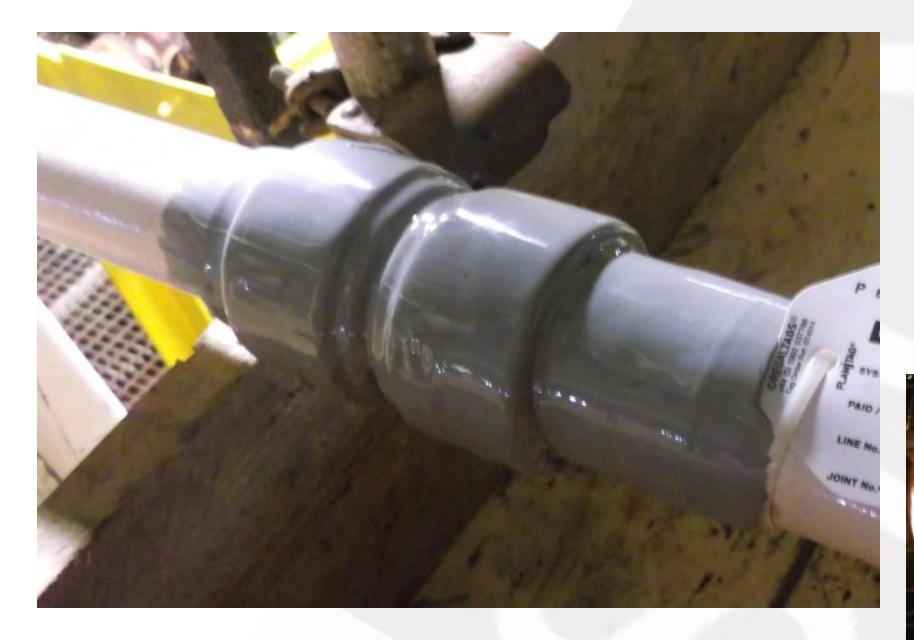
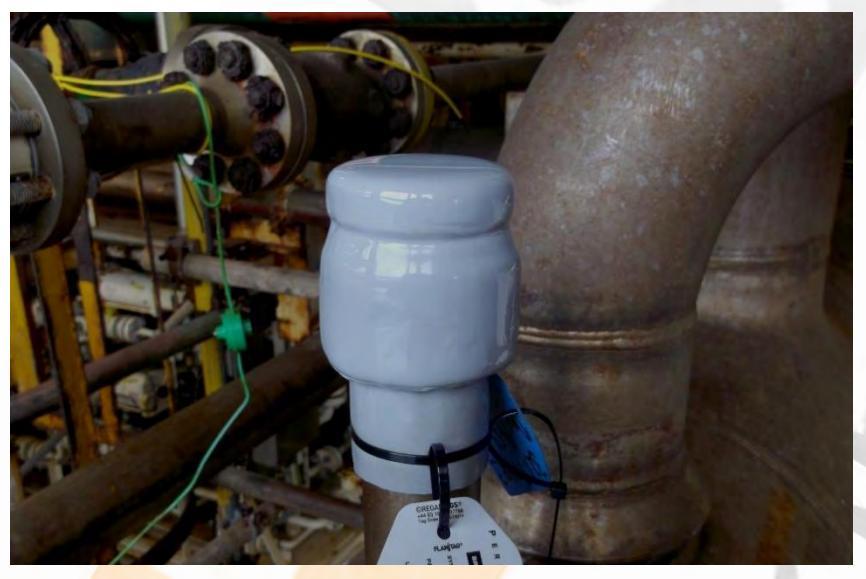
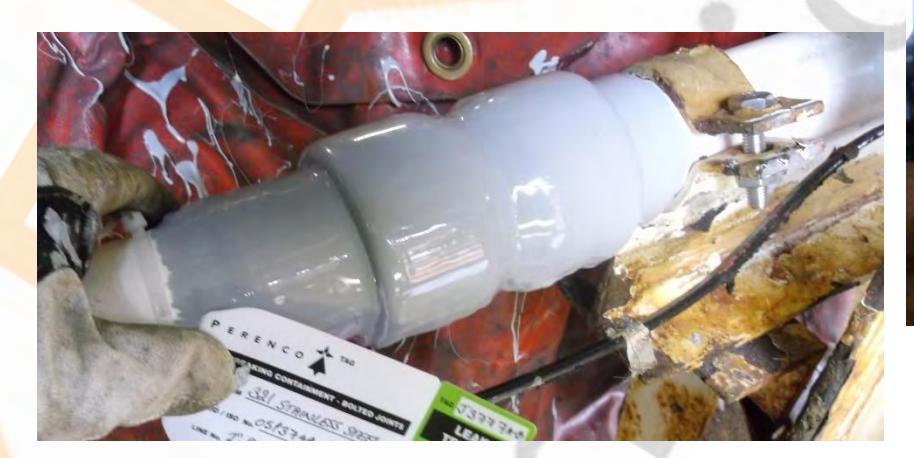
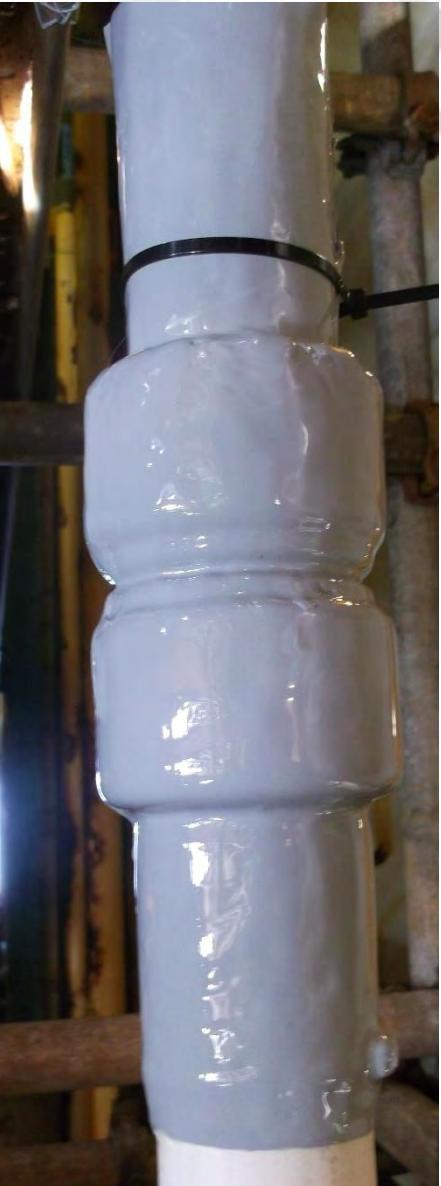
The client presented the stainless steel pipe connectors and they were cleaned down with solvent cleaner and a rag, to remove impurities and saline from the joint.

Each joint was coated with 3 coats of Z-FP in batches of maximum 7 at a time.

Each joint took around 10 minutes per coat and due to the windy conditions, each coat took less than 1 hour to cure
